UTILITY WORK REPORT

FOR: City of Wadley

REPORTING PERIOD: January 1, 2025 - August 10, 2025

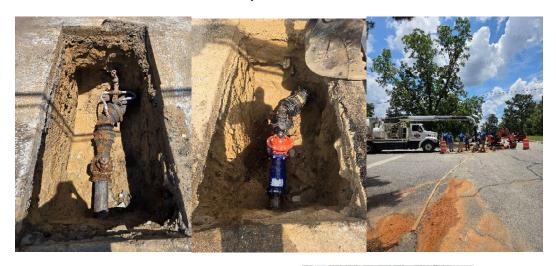
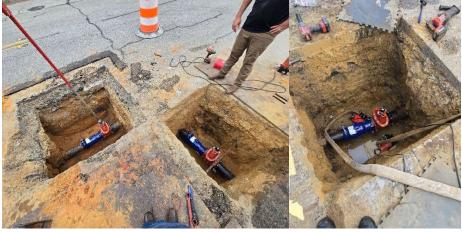
Photo Documentation - Valve Replacements

We replaced **6 water main valves** that had become non-functional or were leaking. New valves were installed with proper traffic control and all lines were flushed and tested upon completion.

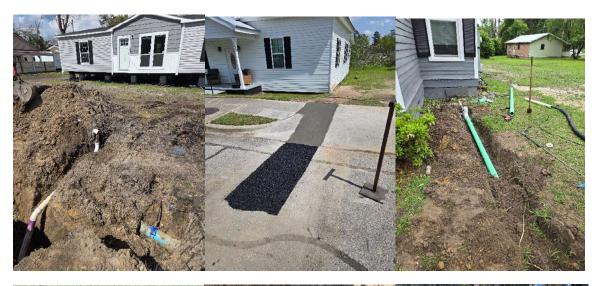
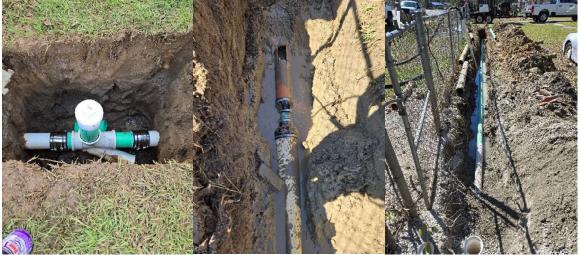
Photo Documentation - Sewer Taps and Repairs

6 new sewer taps were installed, providing service to both new developments and replacement laterals for existing structures. All taps were inspected, and testing confirmed proper flow and installation.

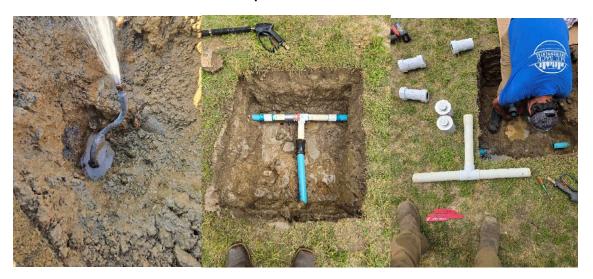
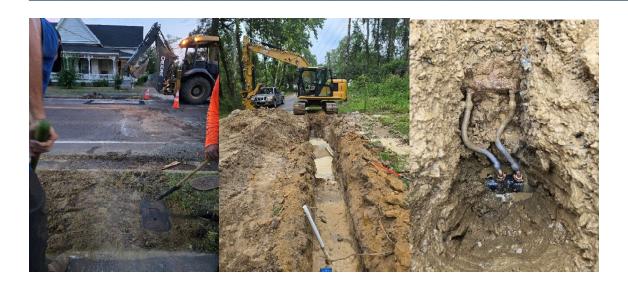
Photo Documentation – Water Main Repairs

We responded to **5 emergency water main ruptures** and completed timely repairs to restore service with minimal disruption. All repairs were disinfected, pressure tested, and logged. Any lead joints or connectors were removed at the time of repair.

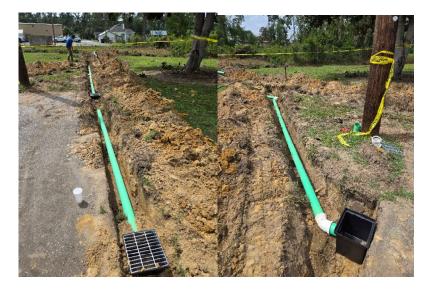
We responded to dozens of calls for ruptured service lines, performing sewer lateral cleanouts and repairing leaking curb valves, meters and other equipment. We also installed a new rainwater drainage system behind city hall to mitigate water ponding in the parking lot and adjacent areas. It is currently in service and will be completed with concrete aprons in the next 2 weeks.
